Intel[®] Mobile Pentium[®] II Processor Specification Update

Release Date: March 2001

Order Number: 243887-030

The Mobile Pentium[®] II processor may contain design defects or errors known as errata which may cause the product to deviate from published specifications. Current characterized errata are documented in this Specification Update.

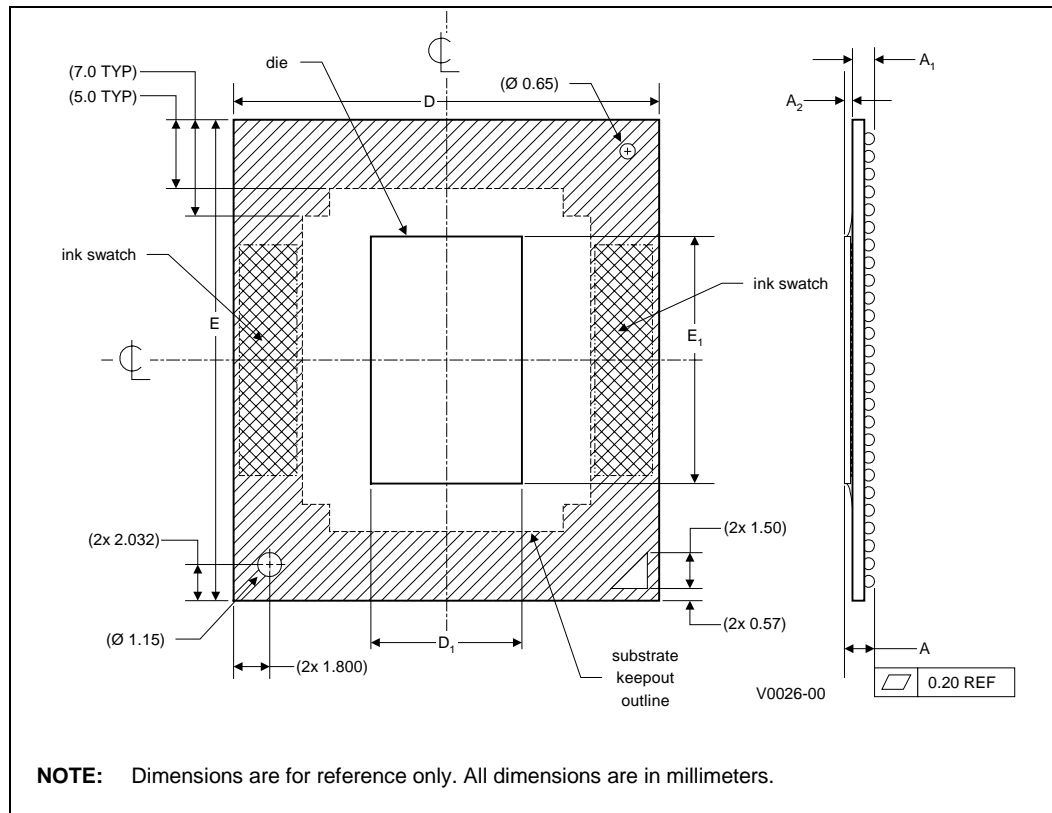
Figure 5.3. Surface-Mount BGA1 Package—Top and Side View

The following table and figures show the updated mechanical specifications for the BGA1 package, listed as Table 5.2, Figure 5.3 and Figure 5.4, respectively, in the *Mobile Pentium® II Processor in BGA Package at 366 MHz, 333 MHz, 300PE MHz, and 266PE MHz* datasheet.

1. The number shown here is different from that in the 243887-010 revision of this specification update. The maximum reference number is used.
